Tips to Avoid Excess Heat

Customer scenario with 5VX900 HY-T WEDGE TORQUE TEAM

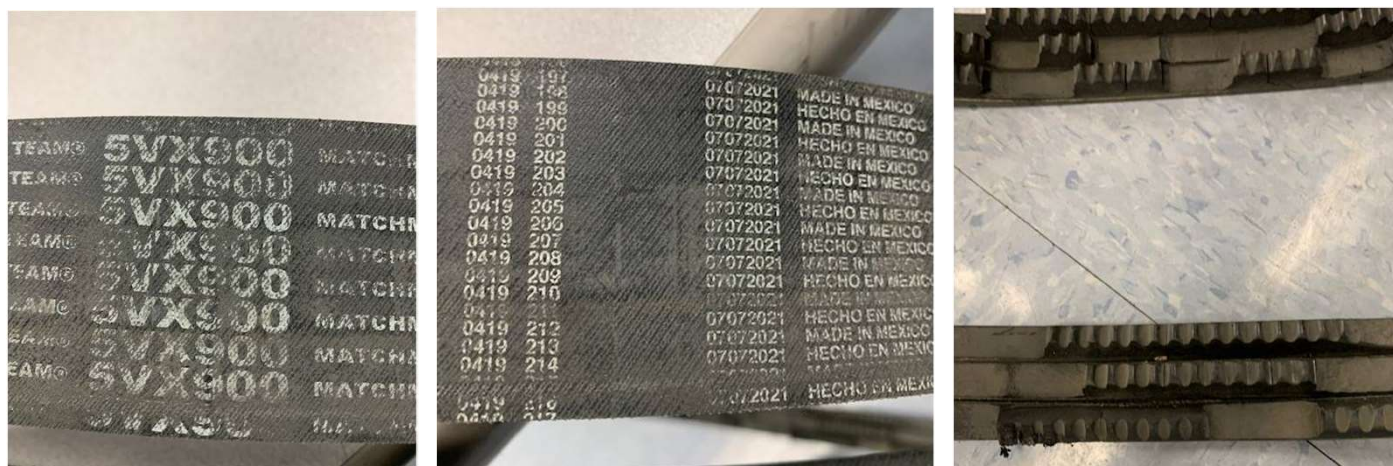
Customer reports that they have had ten 5VX900 HT-Wedge TT belts fail on their application within 3 months. After evaluating the damaged belt images below, flex fatigue cracks can be noticed which is a result of excess heat causing premature cracking:

5VX is EPDM which can withstand heat up to +230degF (most resistant Continental belt to heat). The “X” clarifies that the belt is cogged and more flexible around smaller pulleys compared to 5V wrapped belts. Pending a MaximizerPro drive analysis, below are common system application issues to look for with noticeable fatigue cracking:

- Belt is under powered – Need more belts for the drive
- Belt is operating on too small of pulleys (even for a 5VX belt)
- Poor alignment generating excess heat
- Poor tension control:
 - Over-tension (too much pressure on belt instead of the drive)
 - Under-tension (leads to spin burn)
- Excess ambient heat -- Shield belt drive from heat source (see chart to the right)
